## IMPORTANT SAFETY RECALL INFORMATION

### **Recall Notice for Omni 1.1" Pulley Variants, 20050xxx through 22304xxx: Stop Use, Remove from Service & Return to Rock Exotica**

## Inspection Notice for Omni Pulleys from 2018 through February 2020: Inspect Before Next Use

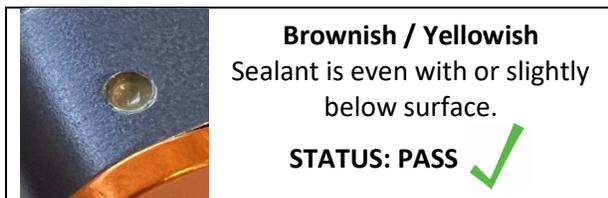
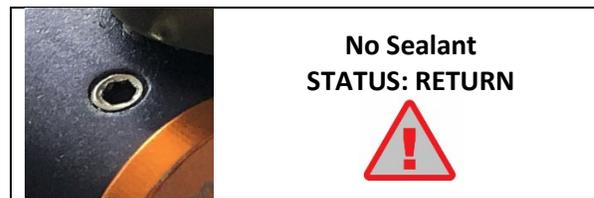
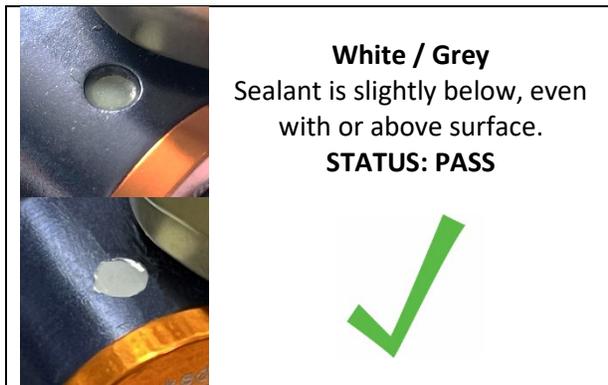
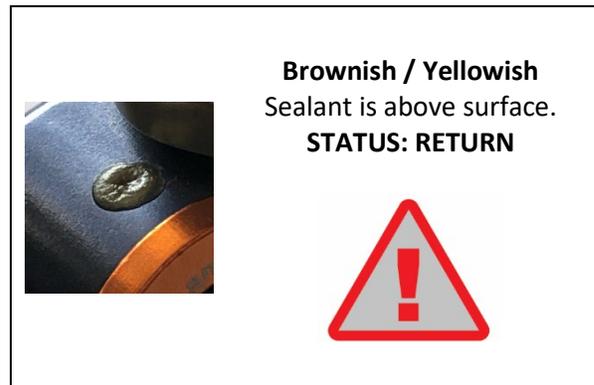
The inspection criteria below apply to Omni Pulleys manufactured from about 2018 to the current date. The serial number corresponding to this period begins at **18001xxx**.

- a) Identify the location of the set screw(s) on your Omni Pulley.
- b) Compare the images in the inspection criteria to your pulley.
- c) Follow the inspection instructions to determine if you are required to return your pulleys for additional inspection by Rock Exotica and repair if necessary.

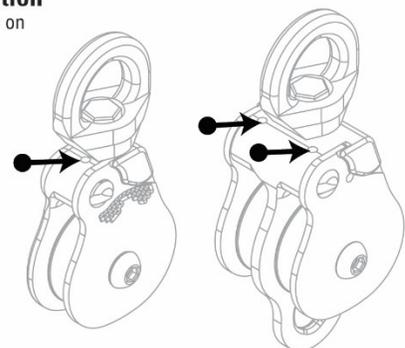
**Set Screw Location**  
is above each button on the Omni

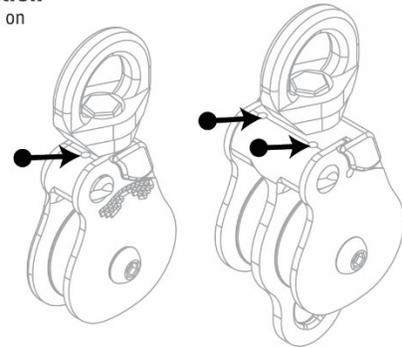
**Approx. 2016 – 2018**  
**White / Grey**  
Sealant is slightly below, even with or above surface.  
**STATUS: PASS**

**Set screw above surface**  
**STATUS: RETURN**

**Set Screw Location**  
is above each button on the Omni

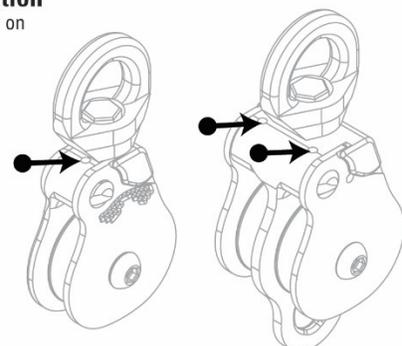
Omni-Blocks prior to about 2016 were made in a slightly different manner. The button set screw has thread lock but no sealant on top of it. The correct position of the set screw is the same as all later Omni's – it should be slightly below the surface (see pictures). Inspect and if yours is not below the surface, please return it and we will repair it.

**2016 & Prior Years**  
Set screw even with surface or slightly below.  
**STATUS: PASS**

**Set screw above surface**  
**STATUS: RETURN**

**Set Screw Location**  
is above each button on the Omni
